Inspection Report

12345 Five St.
Alamosa CO 81101

Denali Home Inspections, LLC

Date: 8/12/2018	Time: 08:00 AM	Report ID: Sample
Property: 12345 Five St. Alamosa CO 81101	Customer: John Samplereport	Real Estate Professional:

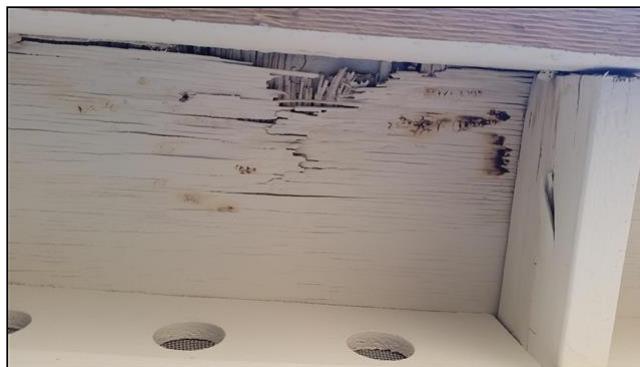
2.5 Item 1(Picture)

(1) Soffit at back patio shows signs of prior leaking and has been damaged.

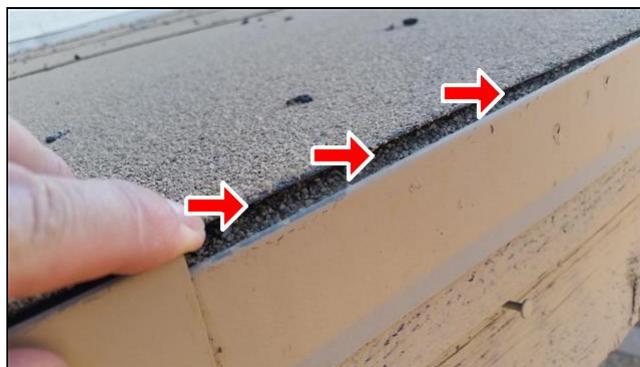
2.5 Item 2(Picture)

(2) Rolled roofing at back patio does not extend past the flashing. Water appears to enter here and is draining into the underlayment causing damage to patio roof.

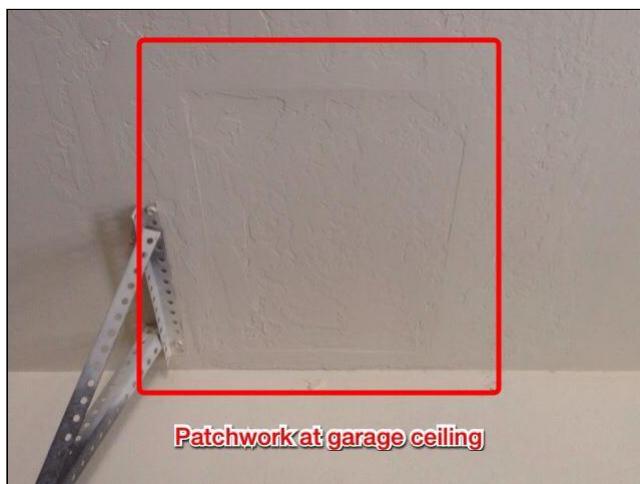
3.0 Item 1(Picture)

(1) A portion of the ceiling in the garage seems to have been patched. Check with the home owner to make sure there was no prior leak.

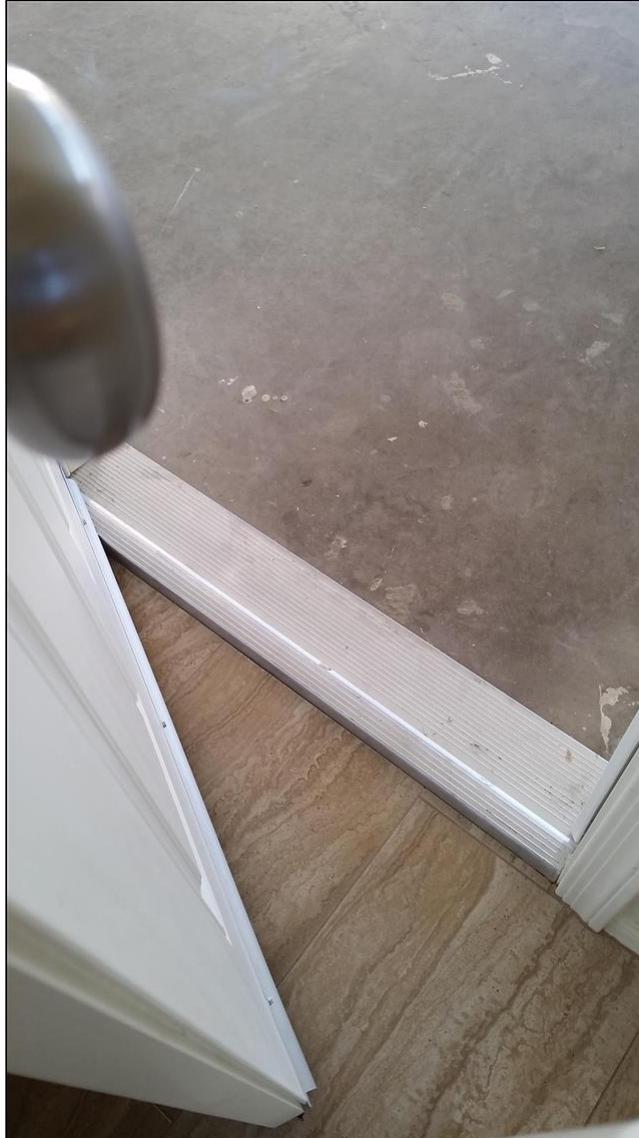
3.0 Item 2(Picture)

(2) A potential trip hazard exists at the door leading from the garage into the house. There is a 4 inch step up into the house.

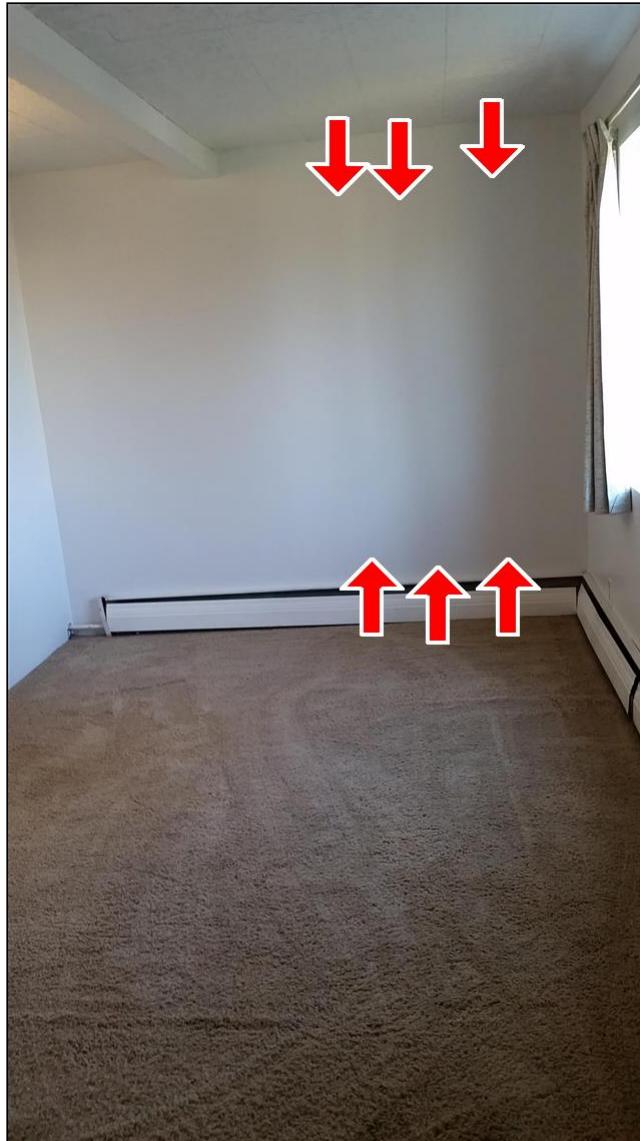
4.1 Item 1(Picture)

Wall in small back bedroom shows signs of thermal bridging, or soot marking (vertical black lines on the walls at the studs) . It usually tells us something about a lack of building insulation or about air leaks in buildings. This should be investigated further by an insulation specialist.

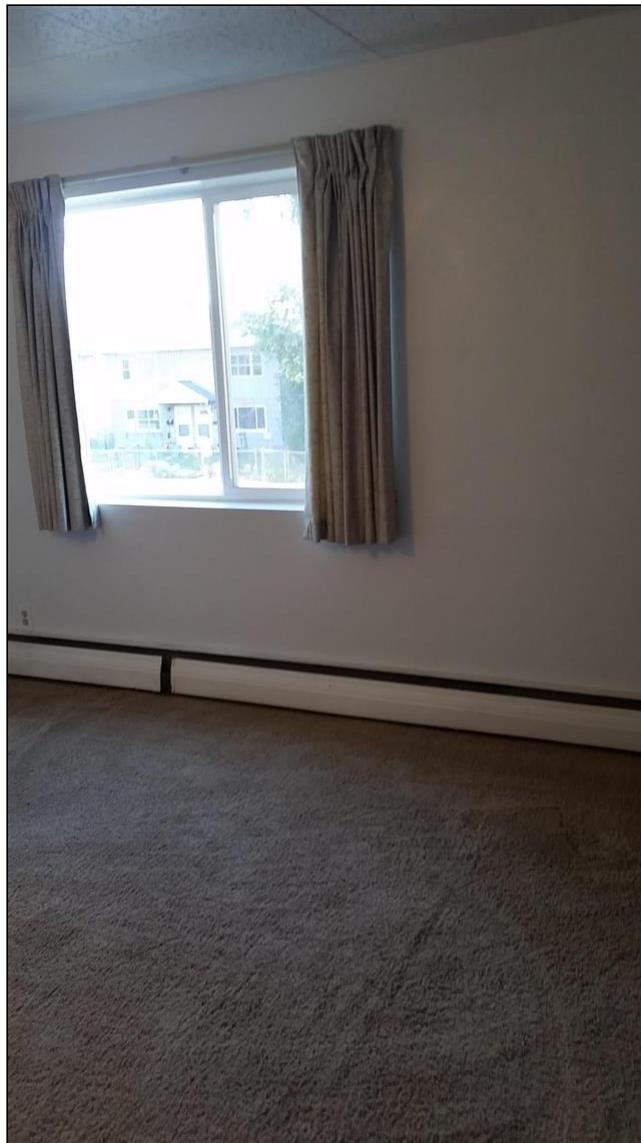
4.6 Item 1(Picture)

(1) Front living room window does not open. It also appears that the seal between the dual panes has become compromised. This reduces the R value of the window and will cause the windows between the panes to fog up. Recommend further evaluation by licensed contractor specializing in windows.

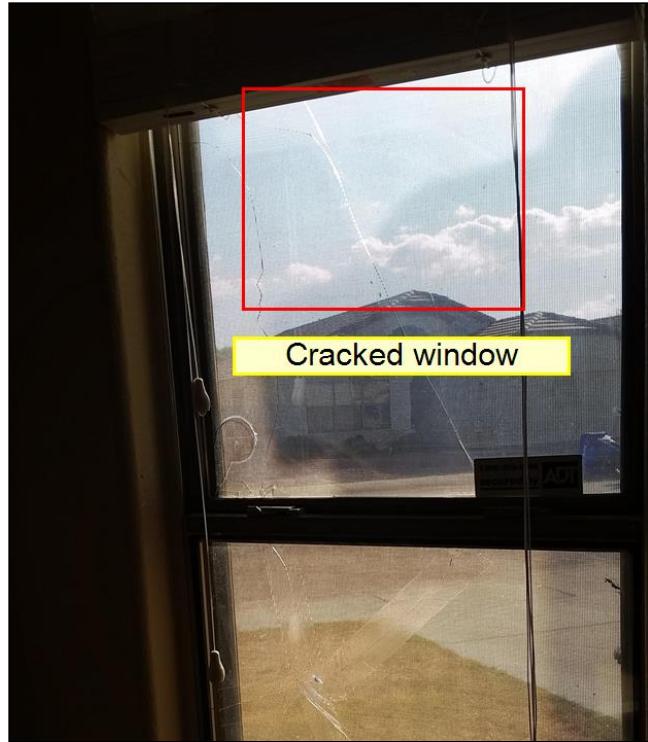
4.6 Item 2(Picture)

(2) There is a cracked window in the back bedroom.

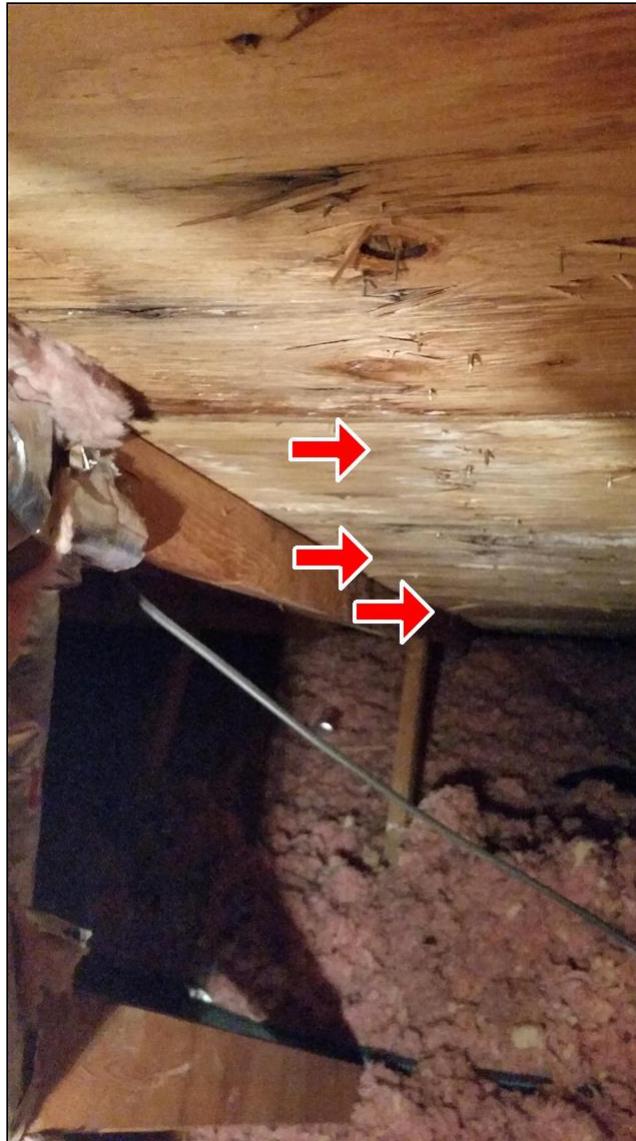
5.5 Item 1(Picture)

- (1) Black mold and moisture damage was found on the underside of the roof covering. Refer to a A Mold specialist for correction.

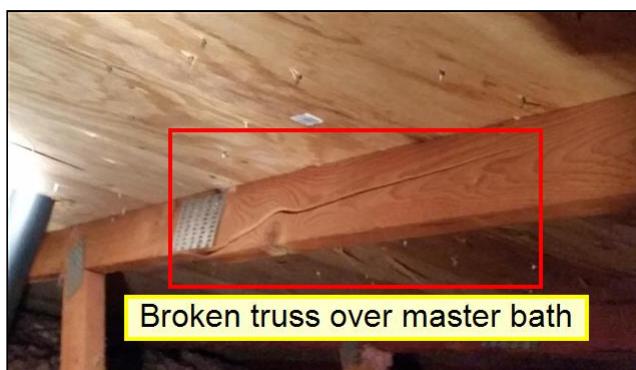
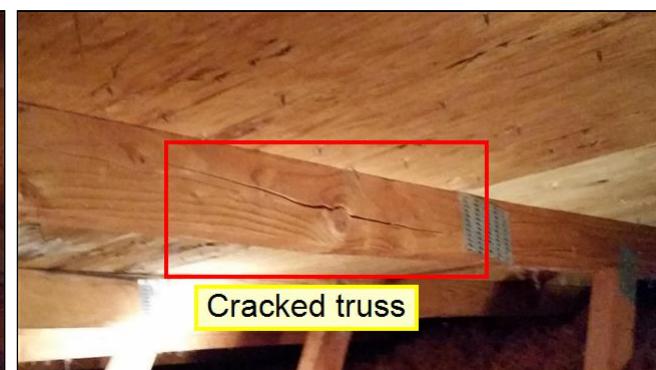
5.5 Item 2(Picture)

(2) There is a broken truss over the master bath and two others that are cracked and failing. This could create a dangerous situation in times of heavy snow loads. Consult a qualified truss engineer.

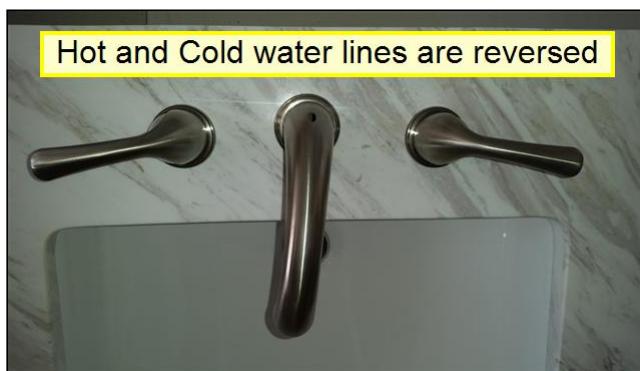
6.1 Item 2(Picture)

- (2) Hot and cold water lines are reversed in the hallway bathroom.

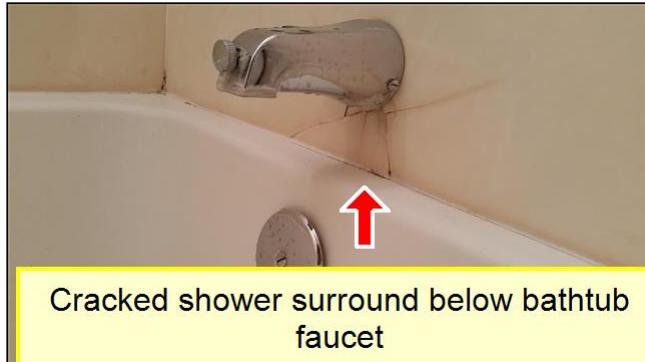
6.1 Item 3(Picture)

- (3) Hallway bathroom shower surround is cracked and damaged below the faucet and needs repair so that water does not seep into the wall and cause damage and/or mold.

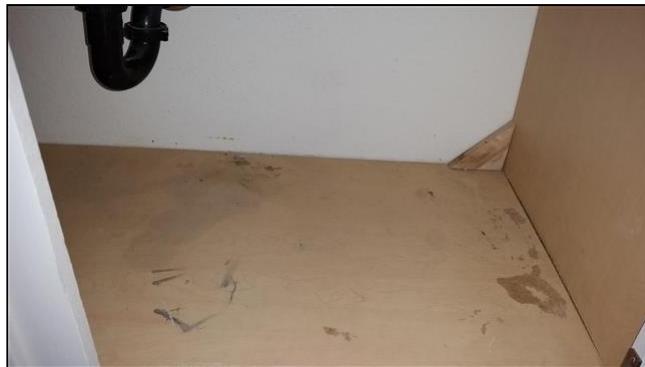
6.1 Item 4(Picture)

(4) Evidence of prior leaking found under hallway bathroom lavatory sink.

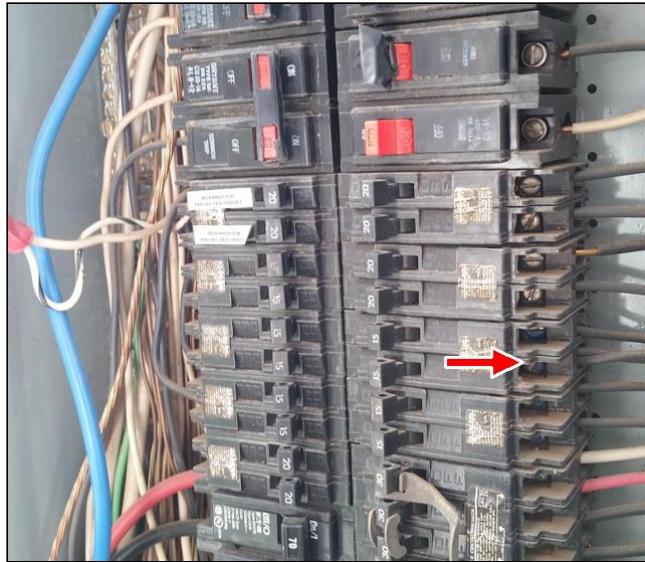
7.1 Item 1(Picture)

A double tapped breaker exists in the main panel. A double tapped breaker is when two wires connect to one breaker. The problem is that it can cause loose connections, arcing, and potentially a fire. Have the panel checked out by a licensed electrical contractor.

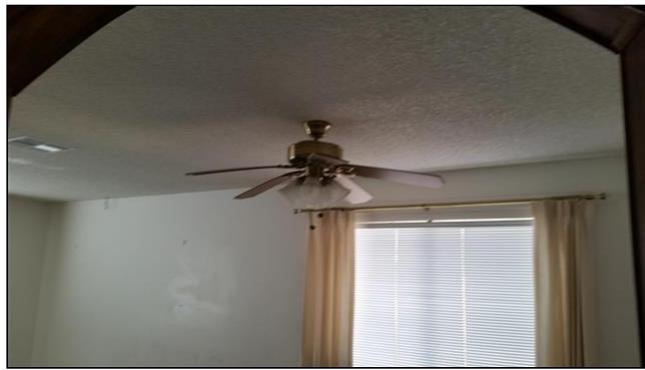
7.3 Item 1(Picture)

- (1) The master bedroom ceiling fan does not function. A qualified licensed electrical contractor should perform repairs that involve wiring.

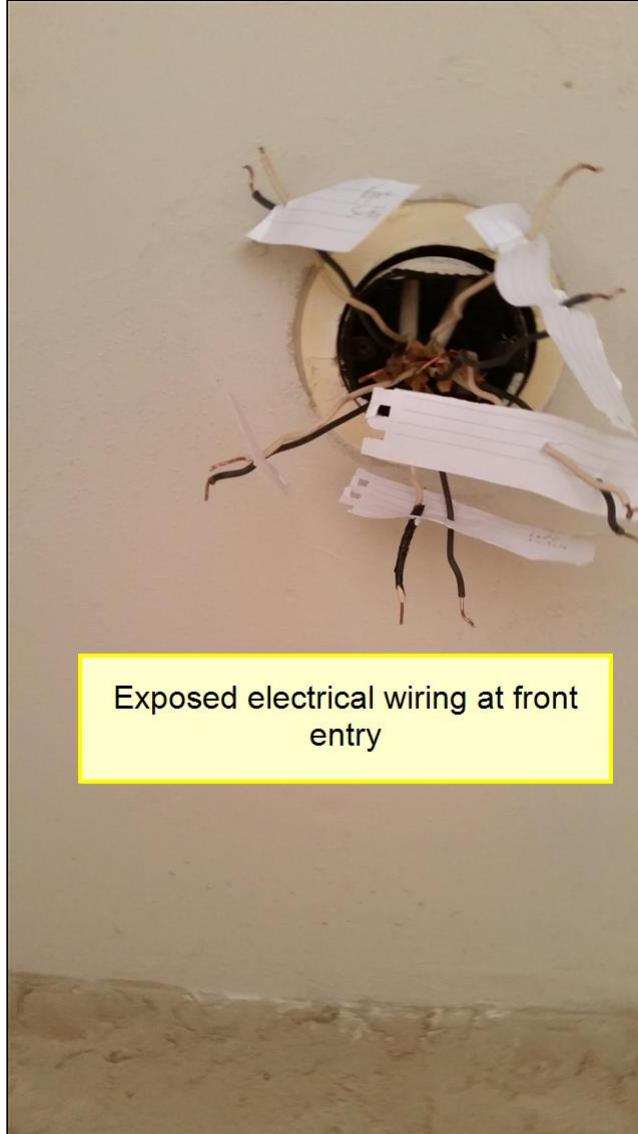
7.3 Item 2(Picture)

- (2) Exposed electrical wiring at front entry pose a high safety risk. A qualified licensed electrical contractor should perform repairs that involve wiring.

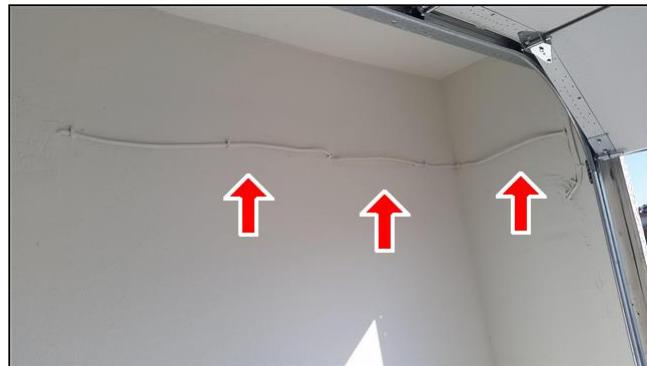
7.3 Item 3(Picture)

(3) Improper wiring found on left side of garage wall. Romex comes out of the wall, runs exposed approximately 6 feet, then re-enters the wall. This creates a highly dangerous situation and should be corrected as soon as possible by a licensed electrical contractor.

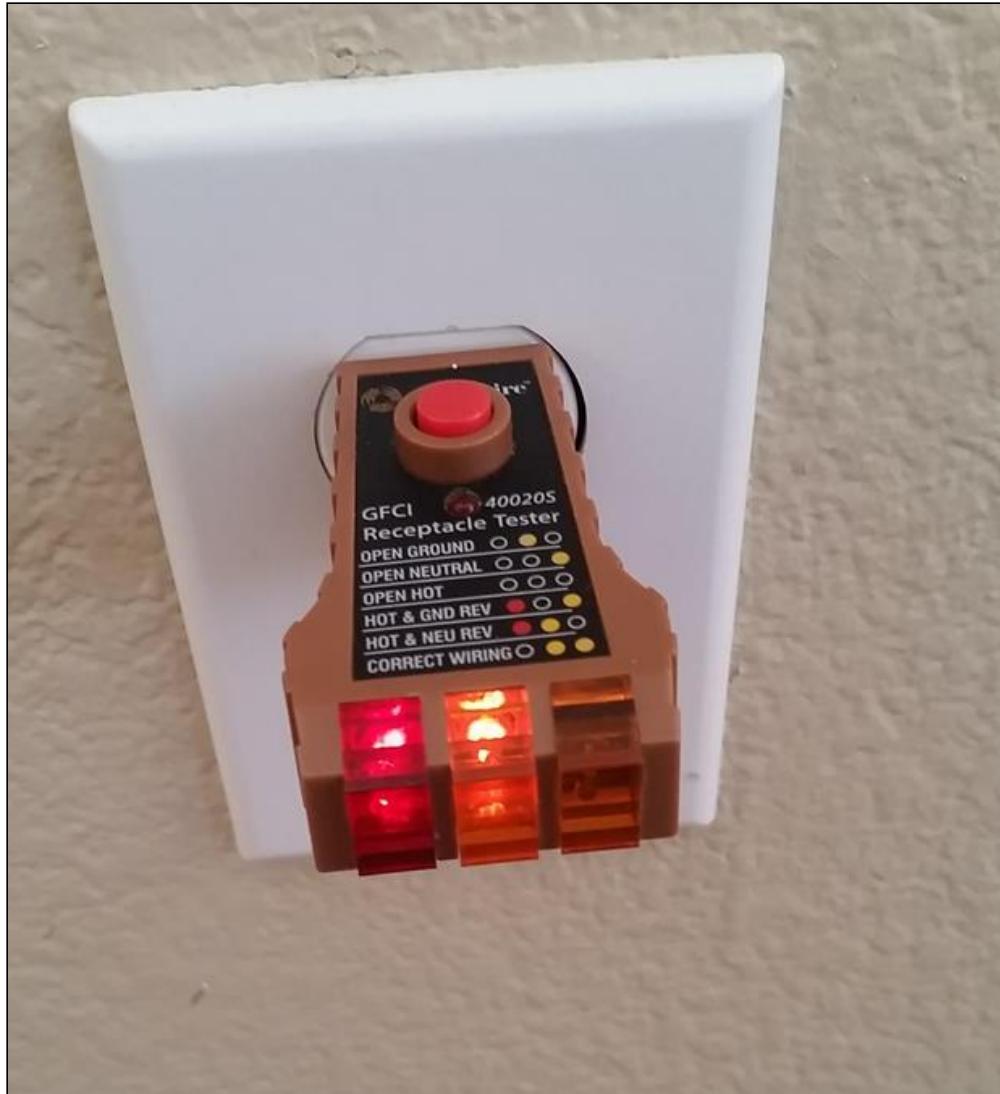
7.3 Item 5(Picture)

(4) Hot and neutral are reversed at outlet under large picture window in the living room. A qualified licensed electrical contractor should perform repairs that involve wiring.

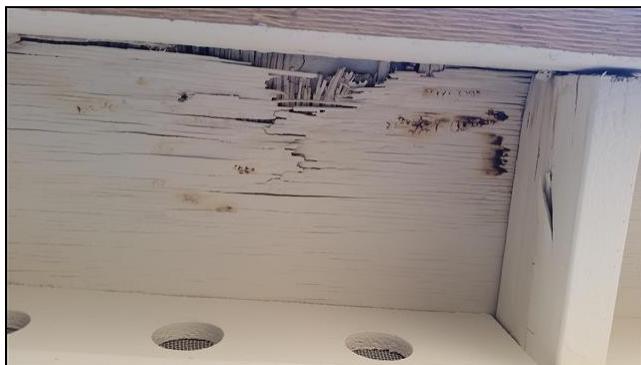
2.5 Item 1(Picture)

- (1) Soffit at back patio shows signs of prior leaking and has been damaged.

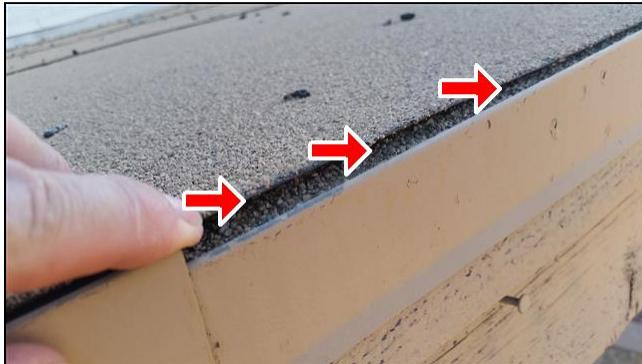
2.5 Item 2(Picture)

(2) Rolled roofing at back patio does not extend past the flashing. Water appears to enter here and is draining into the underlayment causing damage to patio roof.

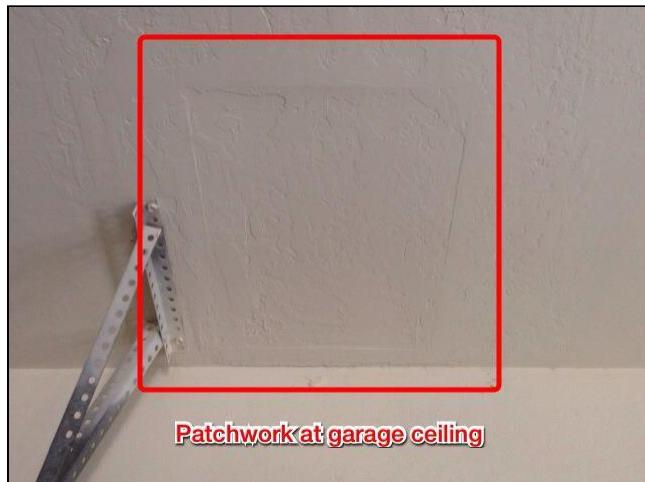
3.0 Item 1(Picture)

- (1) A portion of the ceiling in the garage seems to have been patched. Check with the home owner to make sure there was no prior leak.

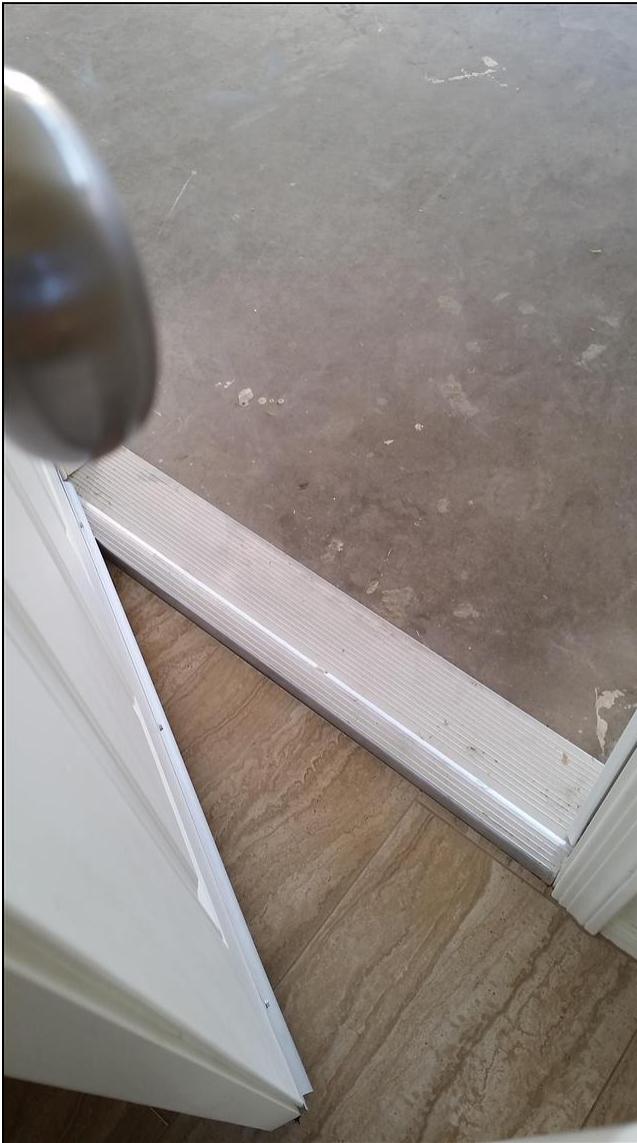
3.0 Item 2(Picture)

- (2) A potential trip hazard exists at the door leading from the garage into the house. There is a 4 inch step up into the house.

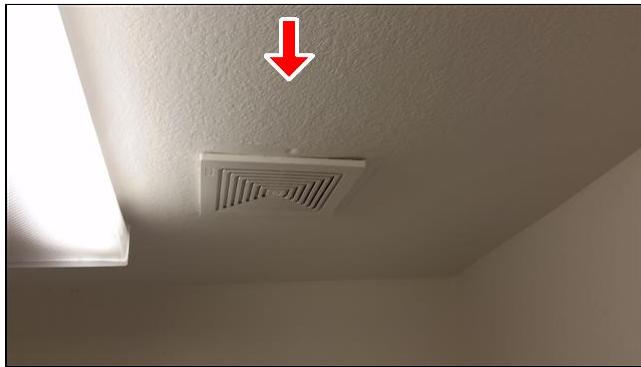
4.0 Item 1(Picture)

Evidence of a prior leak in the ceiling above the washer and dryer exhaust fan. This area has been patched and painted. Ask homeowner about the issue.

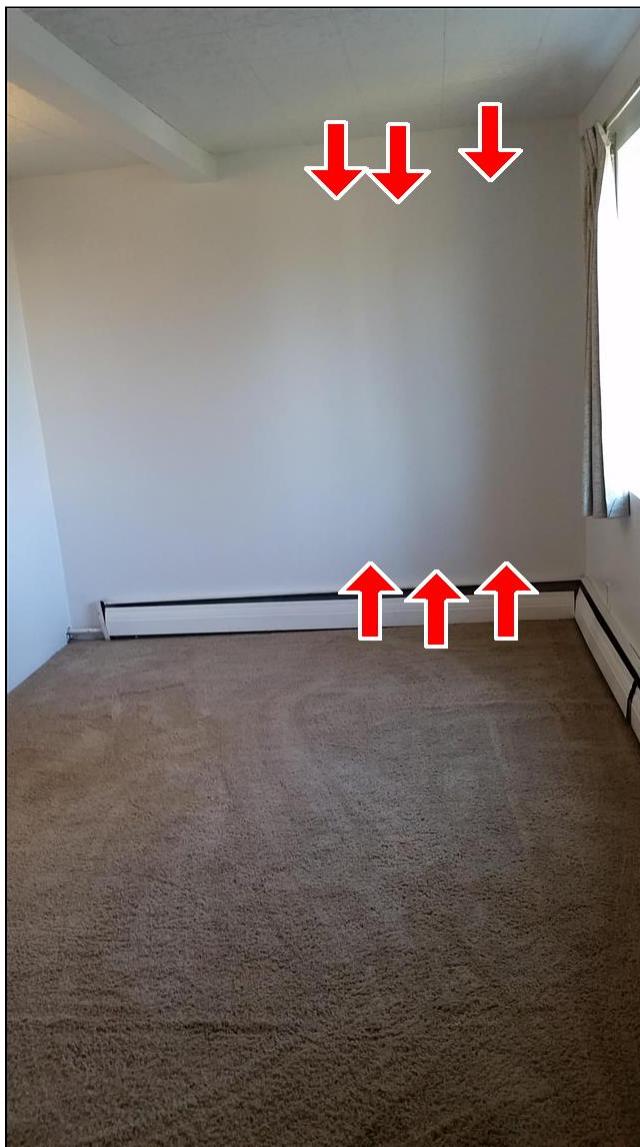
4.1 Item 1(Picture)

Wall in small back bedroom shows signs of thermal bridging, or soot marking (vertical black lines on the walls at the studs) . It usually tells us something about a lack of building insulation or about air leaks in buildings. This should be investigated further by an insulation specialist.

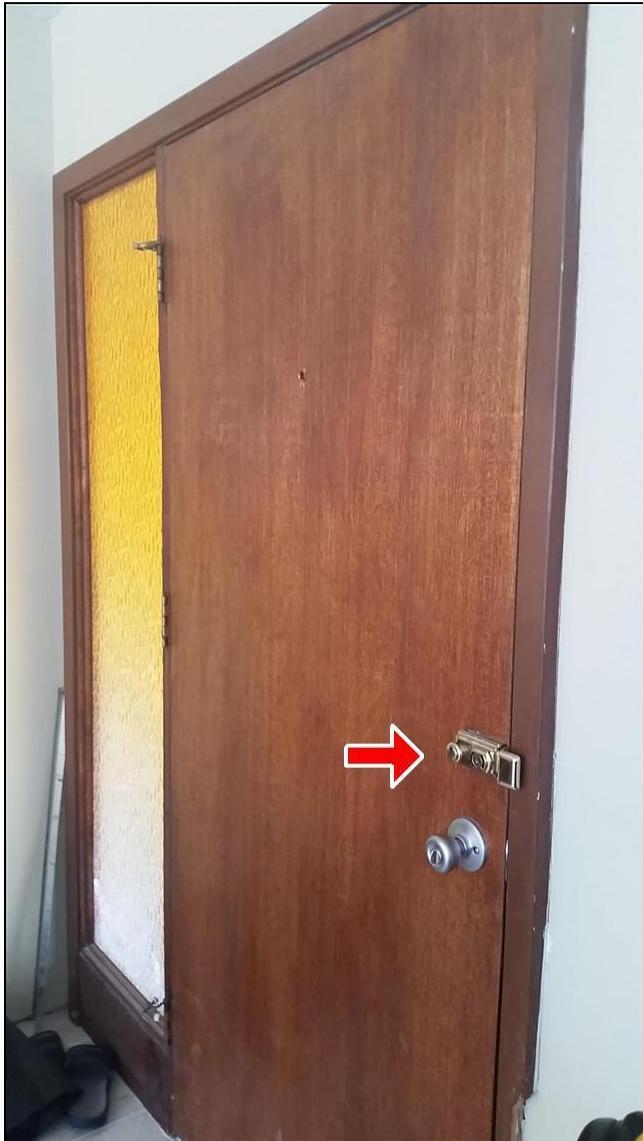
4.5 Item 1(Picture)

Front door dead bolt does not move back and forth to lock the door. Further evaluation and/or replacement needed.

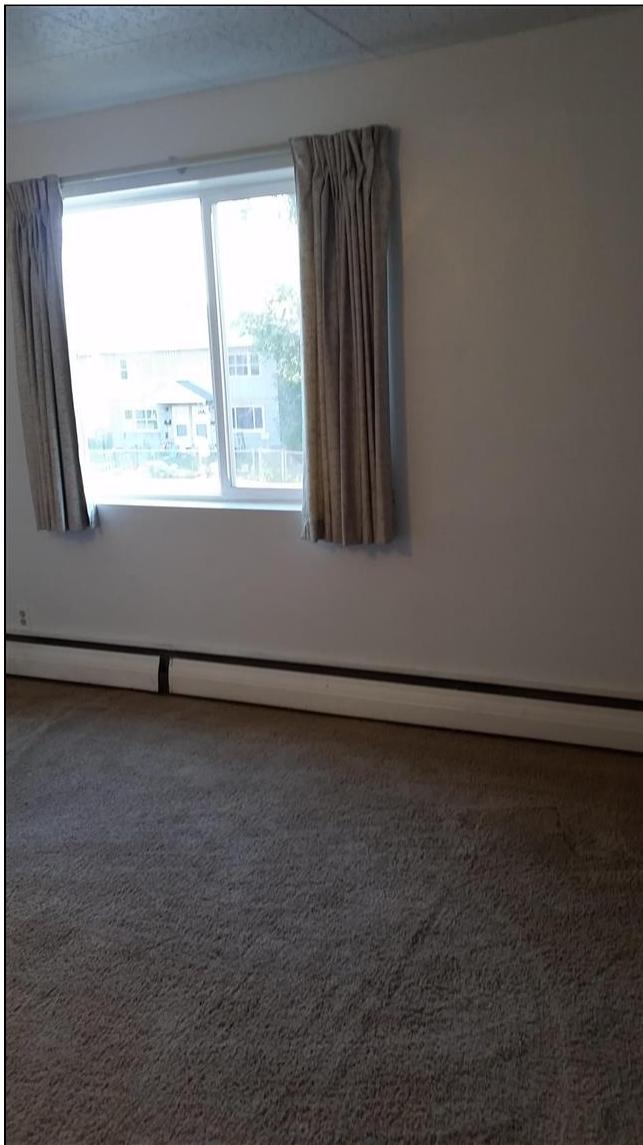
4.6 Item 1(Picture)

(1) Front living room window does not open. It also appears that the seal between the dual panes has become compromised. This reduces the R value of the window and will cause the windows between the panes to fog up. Recommend further evaluation by licensed contractor specializing in windows.

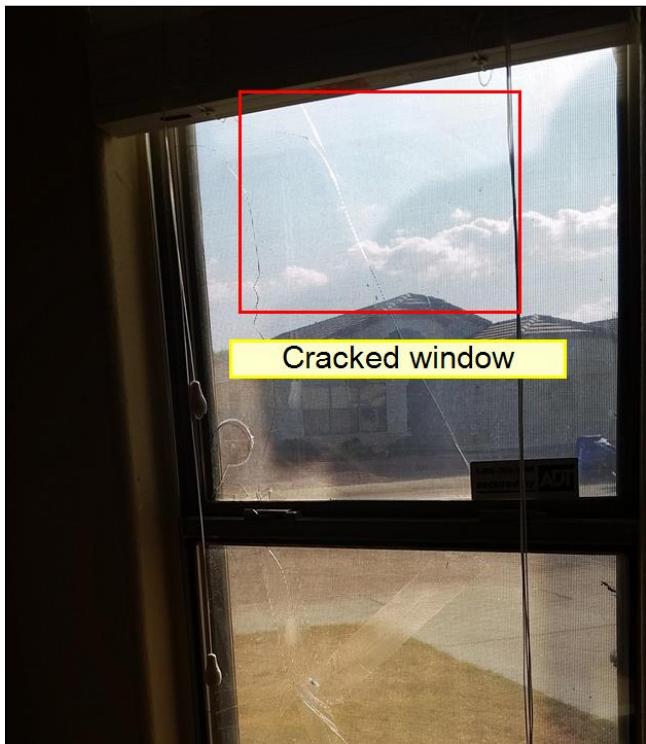
4.6 Item 2(Picture)

- (2) There is a cracked window in the back bedroom.

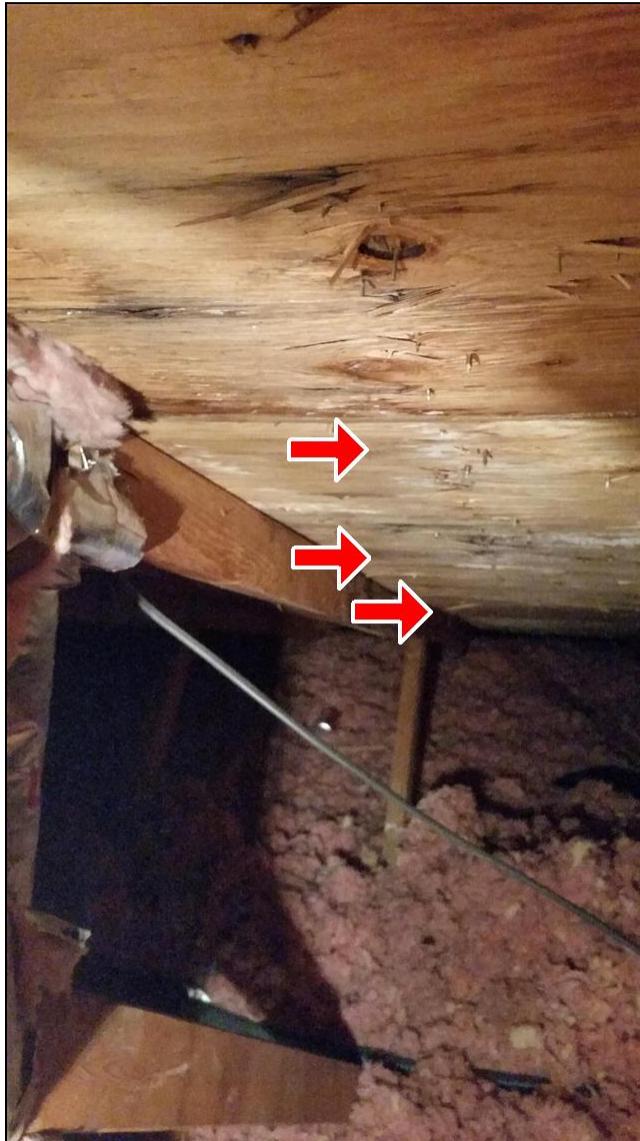
5.5 Item 1(Picture)

- (1) Black mold and moisture damage was found on the underside of the roof covering. Refer to a A Mold specialist for correction.

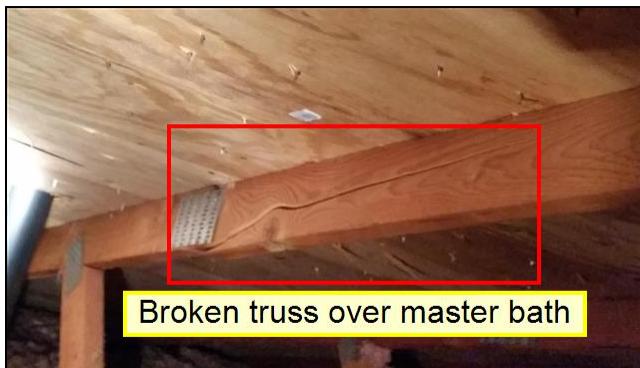
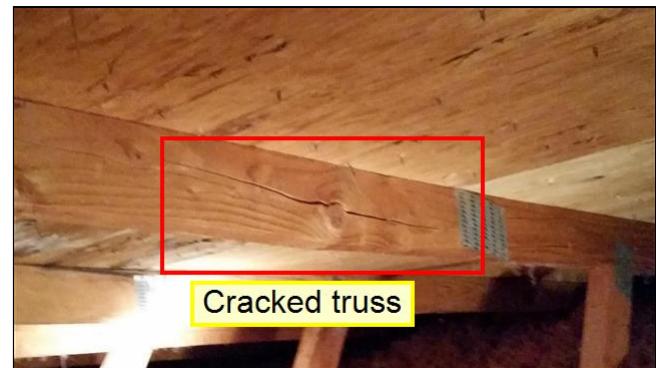
5.5 Item 2(Picture)

- (2) There is a broken truss over the master bath and two others that are cracked and failing. This could create a dangerous situation in times of heavy snow loads. Consult a qualified truss engineer.

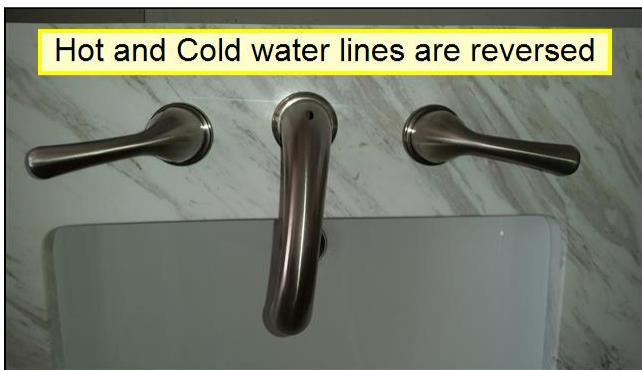
6.1 Item 2(Picture)

- (2) Hot and cold water lines are reversed in the hallway bathroom.

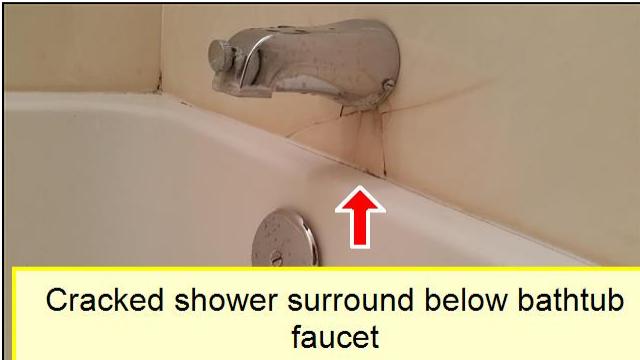
6.1 Item 3(Picture)

- (3) Hallway bathroom shower surround is cracked and damaged below the faucet and needs repair so that water does not seep into the wall and cause damage and/or mold.

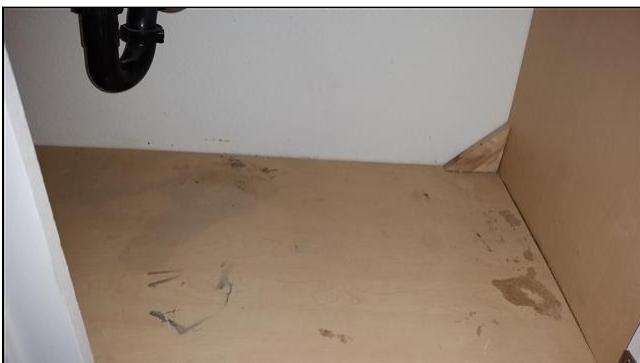
6.1 Item 4(Picture)

- (4) Evidence of prior leaking found under hallway bathroom lavatory sink.

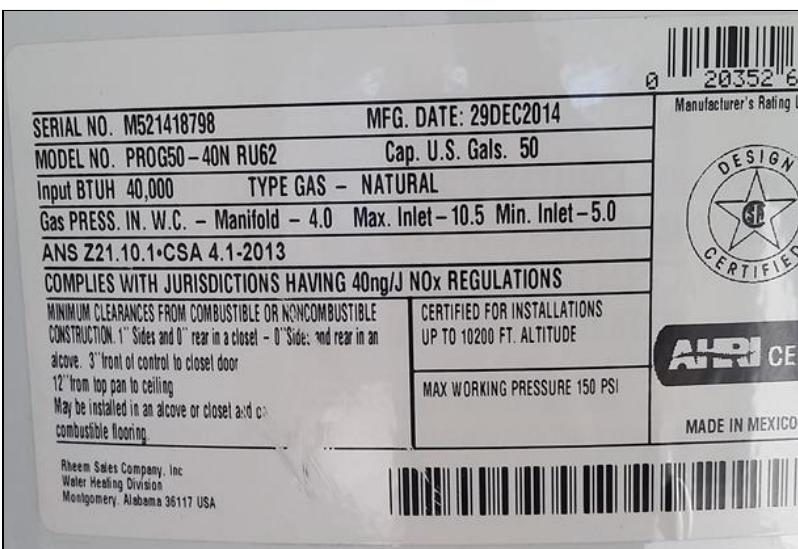
6.2 Item 1(Picture)

Hot water tank information. For your information.

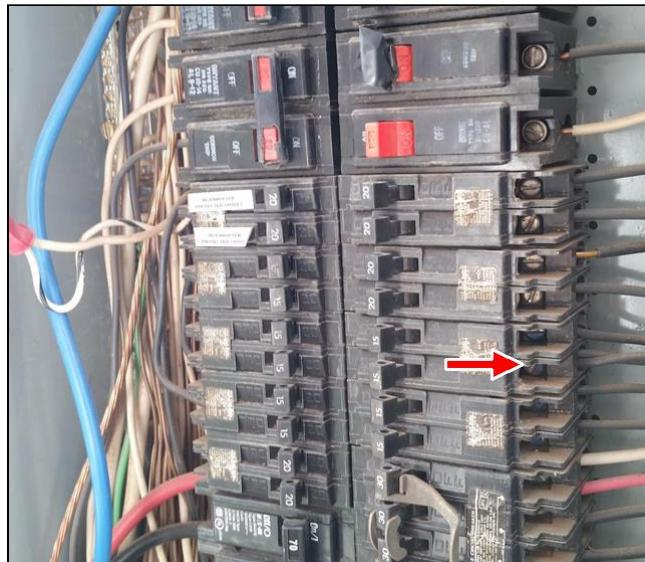
7.1 Item 1(Picture)

A double tapped breaker exists in the main panel. A double tapped breaker is when two wires connect to one breaker. The problem is that it can cause loose connections, arcing, and potentially a fire. Have the panel checked out by a licensed electrical contractor.

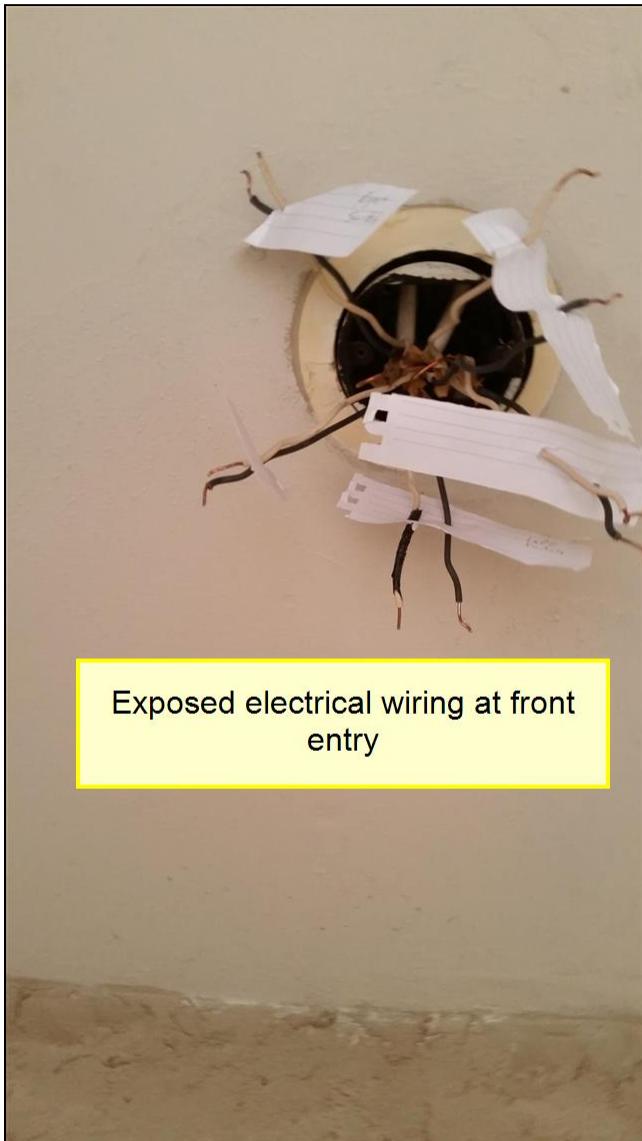
7.3 Item 2(Picture)

- (2) Exposed electrical wiring at front entry pose a high safety risk. A qualified licensed electrical contractor should perform repairs that involve wiring.

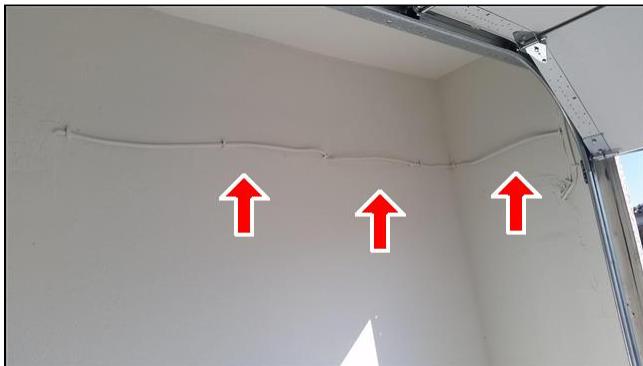
7.3 Item 3(Picture)

(3) Improper wiring found on left side of garage wall. Romex comes out of the wall, runs exposed approximately 6 feet, then re-enters the wall. This creates a highly dangerous situation and should be corrected as soon as possible by a licensed electrical contractor.

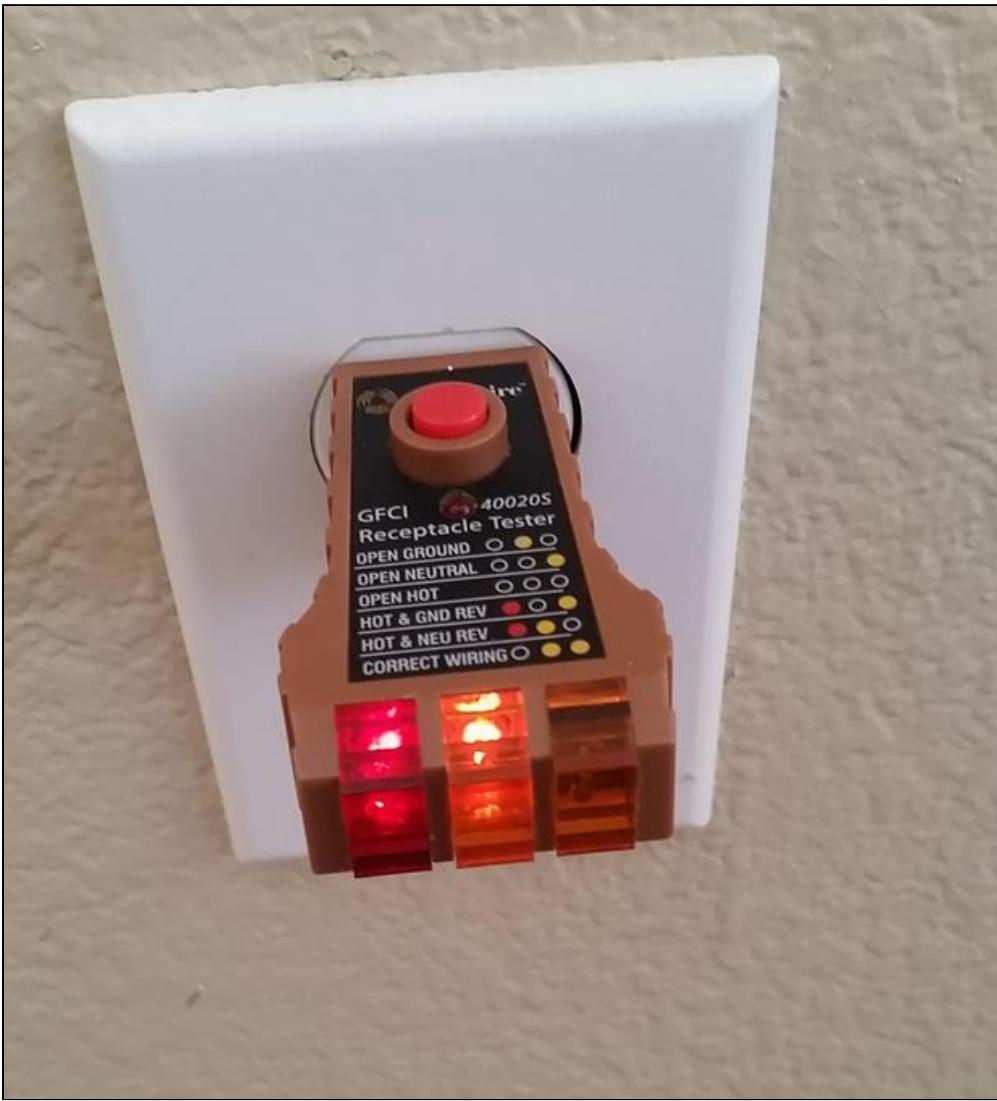
7.3 Item 5(Picture)

- (4) Hot and neutral are reversed at outlet under large picture window in the living room. A qualified licensed electrical contractor should perform repairs that involve wiring.

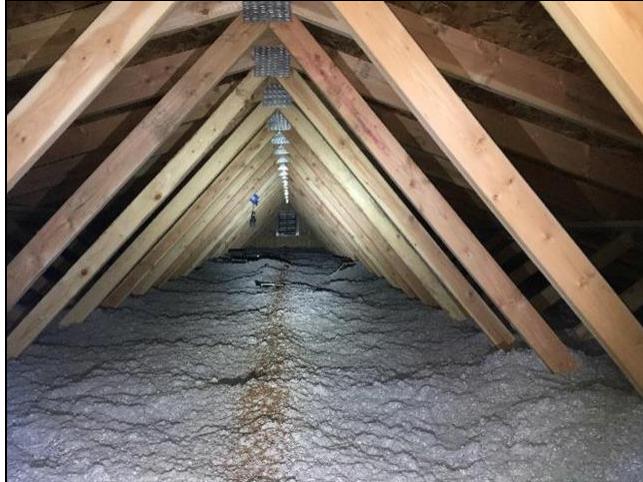
9.0 Item 1(Picture)

Attic insulation was measured around 10 inches thick and consists of blown cellulose. For increased energy efficiency, consider adding an additional 8 inches or more of blown fiberglass or cellulose taking care not to block the eave vents.
